## A METEOROLOGICAL ANALYSIS OF THE AMERICAN AIRLINES FLIGHT 1420 ACCIDENT \*

Erik A. Proseus  
Massachusetts Institute of Technology  
Lincoln Laboratory  
Lexington, Massachusetts 02420-9185

### 1. INTRODUCTION

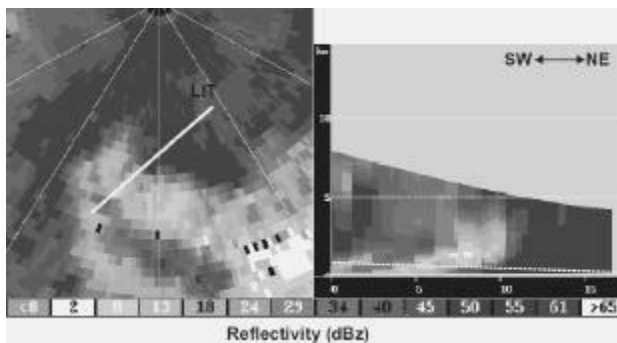
Figure 3. Reflectivity Cross-Section along the Flight Path (04:45:51-04:51:41 UTC).

A cross-section of reflectivity data was made along the final approach path of AAL 1420 and appears in Figure 3. The flight path is indicated by a solid white line in the left panel and by a dashed white line on the right. The right panel also incorporates the aircraft's approximate altitude. The cross-section ends at the runway threshold. From this image, it is possible to see that AAL 1420 encountered heavy precipitation about 9 km (5.6 mi) before reaching the runway threshold and flew through >50 dBz reflectivity for the last 7 km (4.3 mi) of flight.

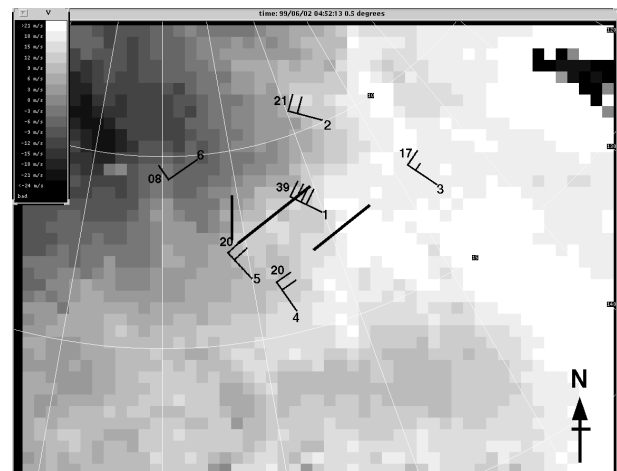
Figure 5. NEXRAD Velocity with LLWAS winds - 04:52:13 UTC.

an increasing southwesterly wind can be seen just west of the airport. This southwest wind is the result of an outflow created by a thunderstorm complex in the same area (see Figure 2). The western-most LLWAS sensor (# 6) depicts this southwesterly wind, while the other sensors continue to show a northwesterly wind. The image in Figure 6 is taken about eight minutes after the accident. By this time, the storms have moved directly over the runways and a microburst signature is present over the airport. The LLWAS sensors are more variable and indicate a definite divergent signature over the airport. The divergence is especially noticeable between sensors 5 and 6, where a 48-knot speed differential is observed. This signature was not present over the runways in Figure 5, so it is safe to assume that the microburst did not affect the airport until after the accident. It is quite likely that this divergent signature not only advected onto the airport with the storm complex, but also strengthened considerably, as the previous image does not show divergence of this magnitude. Thus, according to the NEXRAD and LLWAS data, the aircraft was experiencing a fairly significant crosswind (both in the final stages of flight and at touchdown), but there are no signs of significant wind shear until after the accident occurred.
